Important Safety Information on Baxter Intravenous Solution Bags – Potential Leak During Spiking of Administration Port

October 6, 2023

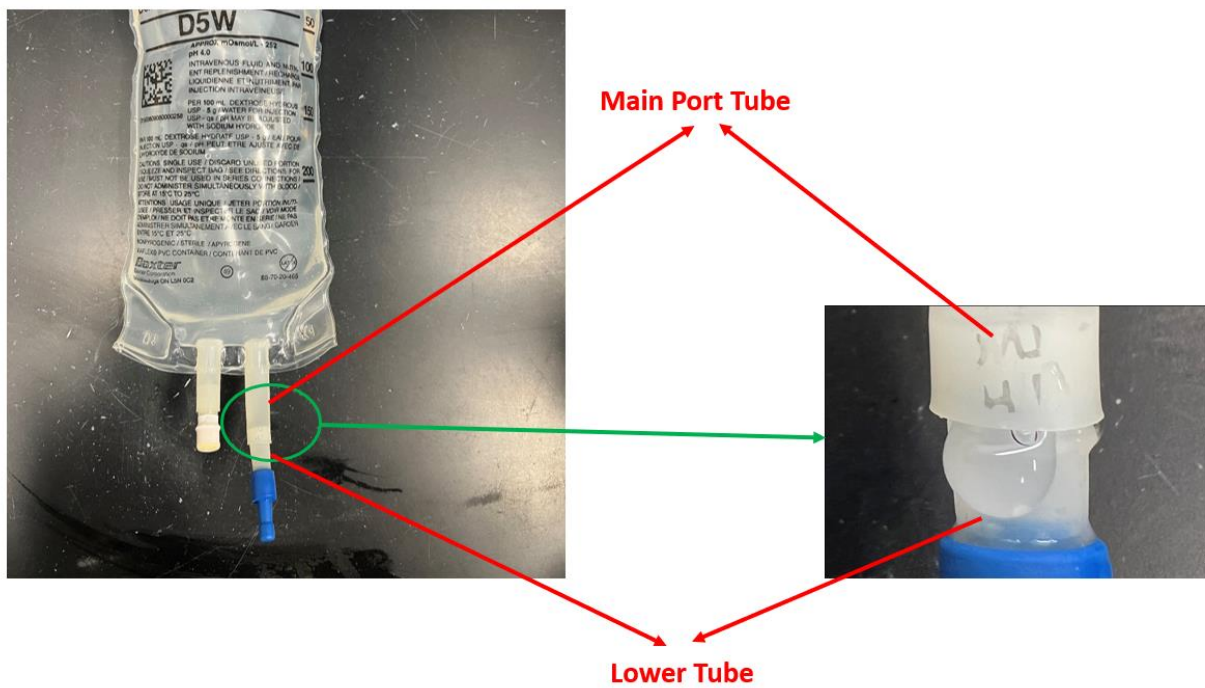
There have been reports of leaks and/or disconnections observed during spiking on the administration port at the connection of the lower tubing section and the main port tube (see Appendix B as an example).

Baxter identified the cause of the leakage of these intravenous bags as a combination of factors related to the manufacturing process. Baxter has implemented appropriate measures to address the leaks and prevent reoccurrence. Products from the affected lots were distributed by Baxter Corporation in Canada beginning April 28, 2023.

The following photo is an example of where the leaks can occur for the implicated lots:

- Visually inspect the container. If the administration port is damaged, detached, or not present, discard container, as solution sterility may be compromised.

- Check for administration port leaks after spiking the bag, by applying gentle pressure near the administration port. If leaks are found, discard solution as sterility may be compromised.
