# URGENT MEDICAL DEVICE CORRECTION

October 20, 2022

**Problem Description** Baxter Corporation is issuing an Urgent Medical Device Correction to the user level for the Novum IQ Large Volume Pump (LVP). This correction is related to two different software issues that occur during use. These issues apply to both currently marketed software versions 1.1.3 and 1.1.4 unless otherwise noted below. The issues do not occur for infusions run to completion.

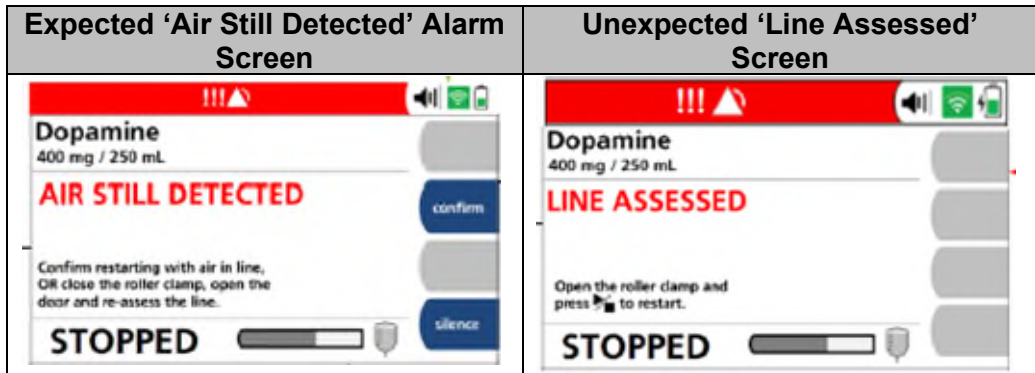
Figure 1: Expected and Unexpected Screen Transition During the 'Air Still Detected' Alarm Workflow

The second issue observed is an unexpected screen transition during the 'Air Still Detected' Alarm workflow. The issue occurs when the user is resolving a high priority 'AIR IN LINE' alarm, elects to continue the infusion and does not clear the air in line. The issue results in cases where the 'Air still Detected' alarm does not occur.

Instead, the pump transitions directly to the 'Line Assessed' screen with high priority alarm visual indicators i.e., alarm banner on display and red flashing beacon light.

These alarm visual indicators (alarm banner and red flashing beacon) persist for the remainder of the infusion and do not clear until the user opens the door. While these alarm visual indicators are present, any alarms of relatively lower priority than the “Air Still Detected” alarm are not presented to the user i.e. displayed or accompanied with an audible alarm such as Upstream or Downstream occlusion alarms. See the Operator’s Manual, Table 8-2 General Alarms for the complete list of alarm prioritization.

3. For the second issue for 'Air Still Detected' Alarm workflow, if operators encounter the 'Line Assessed' screen with alarm banner and red flashing beacon (See Figure 3, right image), operators **should not** resume the infusion.

- Users should open the door,
- Re-assess the line for air,
- Remove any residual air in the line per hospital policies

- Close the door again.

Operators should only resume the infusion when the 'Line Assessed' screen **without** alarm banner and red flashing beacon (See Figure 3, left image) is displayed after door closure.

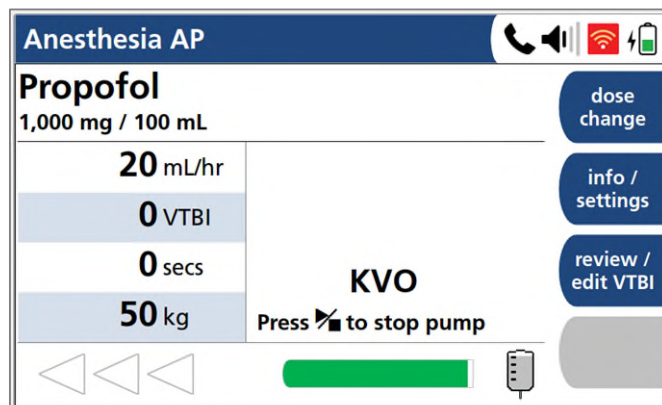
Figure 2: Unexpected KVO Screen

1. The infusion may transition to KVO (keep vein open) prematurely after bolus completion. Furthermore, this transition to KVO is not accompanied with a high priority "Infusion Complete" alarm as expected.
2. The infusion following the bolus may have an incorrect remaining VTBI and can result in insufficient or excessive therapy.  
For example, if a primary infusion is programmed for 100 mL and a Bolus of 10 mL is programmed 20 mL into the primary infusion, the expected remaining VTBI would be 70 mL. In the case of this software issue, the remaining VTBI is incorrectly calculated to be more or less than 70 mL.

1. The infusion may transition to KVO prematurely. Furthermore, this transition to KVO is not accompanied with a high priority "Infusion Complete" alarm as expected. **This only applies to Novum IQ LVPs**

Monitor the patient during bolus delivery to completion or minimally at completion to ensure appropriate return to the maintenance rate. Upon completion of the bolus if a premature transition to KVO occurs (See Figure 2).

- Press the 'run/stop' key to stop the infusion
- Select 'review / edit VTBI' soft key
- Select 'edit program'
- Reprogram the VTBI
- Press the 'run/stop' key to resume the infusion
