URGENT MEDICAL DEVICE CORRECTION

May 29, 2023

Problem Description

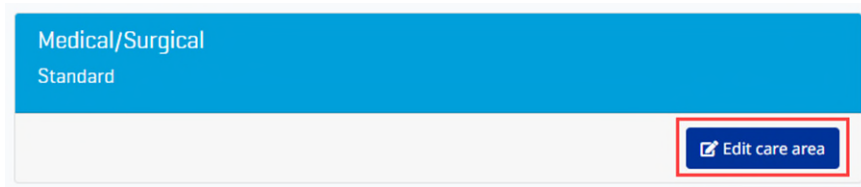
Figure 2

- iii. Under the **Threshold for air in line detection (µL)**, if the value shows **blank**, this care area is affected. If there is a value displayed in this field (50, 100, 200 or 400), this care area is not affected.
- iv. To correct a care area with a **blank** value, please do the following:
 - a) Access the **Care Area page** in Dose IQ Web software
 - b) Select **Edit care area** button (See Figure 2)

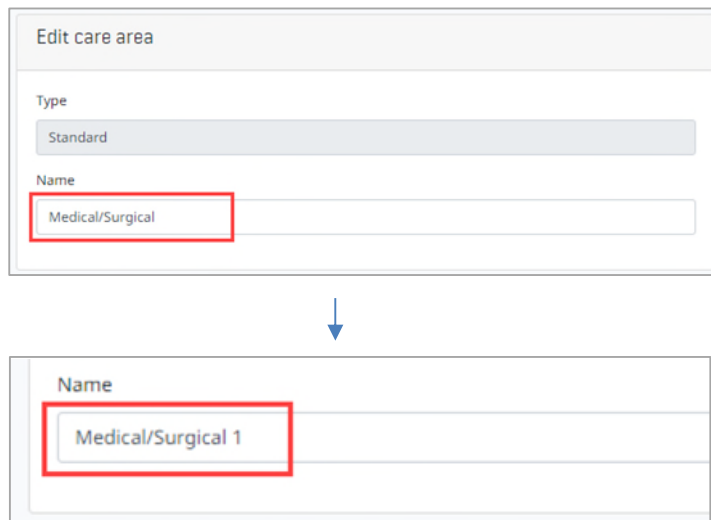
Figure 3

- c) In the **Care Area Name** field, rename the Care Area name. (e.g. add an alphanumeric character) (See Figure 3)

NOTE: For OR or Anesthesia, a space is required between the name OR or Anesthesia and the new character. (E.g. OR 1, or Anesthesia 1)

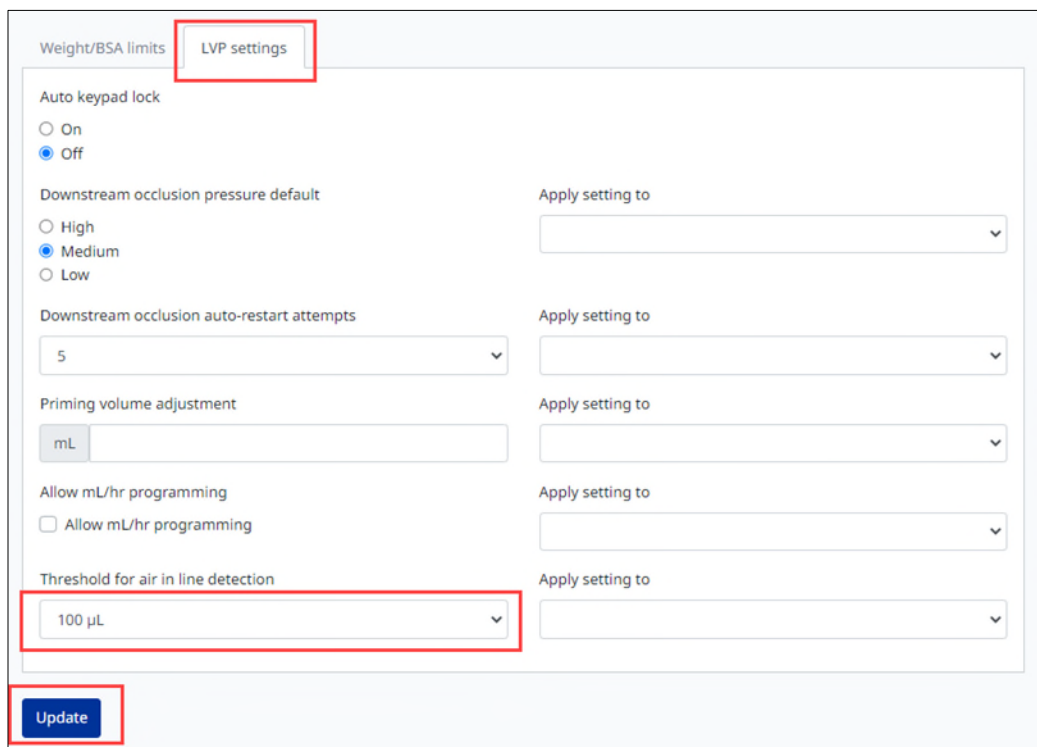
Figure 4

- d) Next, select the **LVP settings** tab (See Figure 4)
- e) View the **Threshold for air in line detection** setting. (See Figure 4)
Note: The value of **100 µL** will be displayed. (See Figure 4)
- f) From the dropdown menu, select the required threshold if different from the displayed **100 µL** (See Figure 4)
- g) Click **Update** to confirm and save setting (see Figure 4)
NOTE: Repeat steps iv a) to g) for each Care Area that may be affected.

- h) Next, follow the steps to generate a new BDL file using the **BDL Exports** function from the **Dashboard** page.
- i) Review the Clinical Validation Report (see Step ii above) and confirm the **Threshold for air in line detection (µL)** values are correct for all care areas and no blanks are observed.
- j) Create the new BDL file
- k) **Transfer the new BDL file** to all infusion pumps in your hospital fleet.
Note: The new BDL file must be transferred to all pumps to resolve this issue.

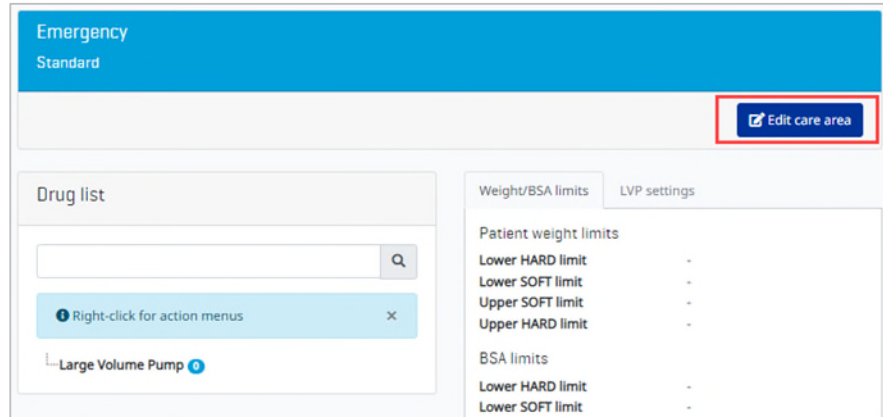
Figure 5

- a) Upon creating the new Care Area name, select **Edit care area** button within the new Care Area. (See Figure 5)

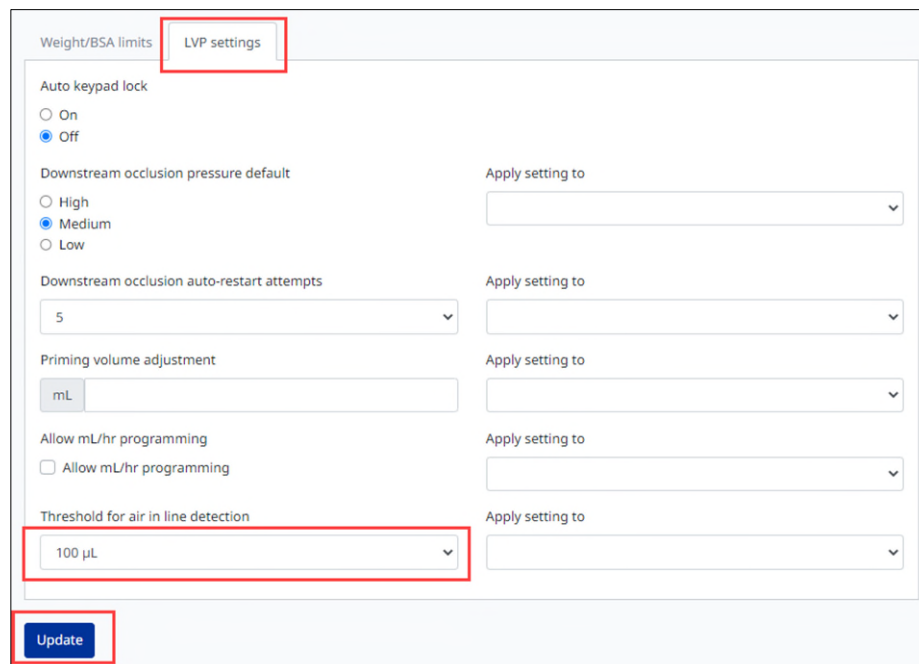
Figure 6

- b) Next, select the **LVP settings** tab (see Figure 6)
- c) View the **Threshold for air in line detection** setting. (See Figure 6)
- d) From the dropdown menu, select the required threshold if different from the displayed **100 μ L** (see Figure 6)
- e) Click **Update** to confirm and save setting (see Figure 6)
